Community Health Center Stamford, Connecticut

- TYPE
Commercial
- SIZE
2,000 sq. ft
- COMPLETION
July 2019

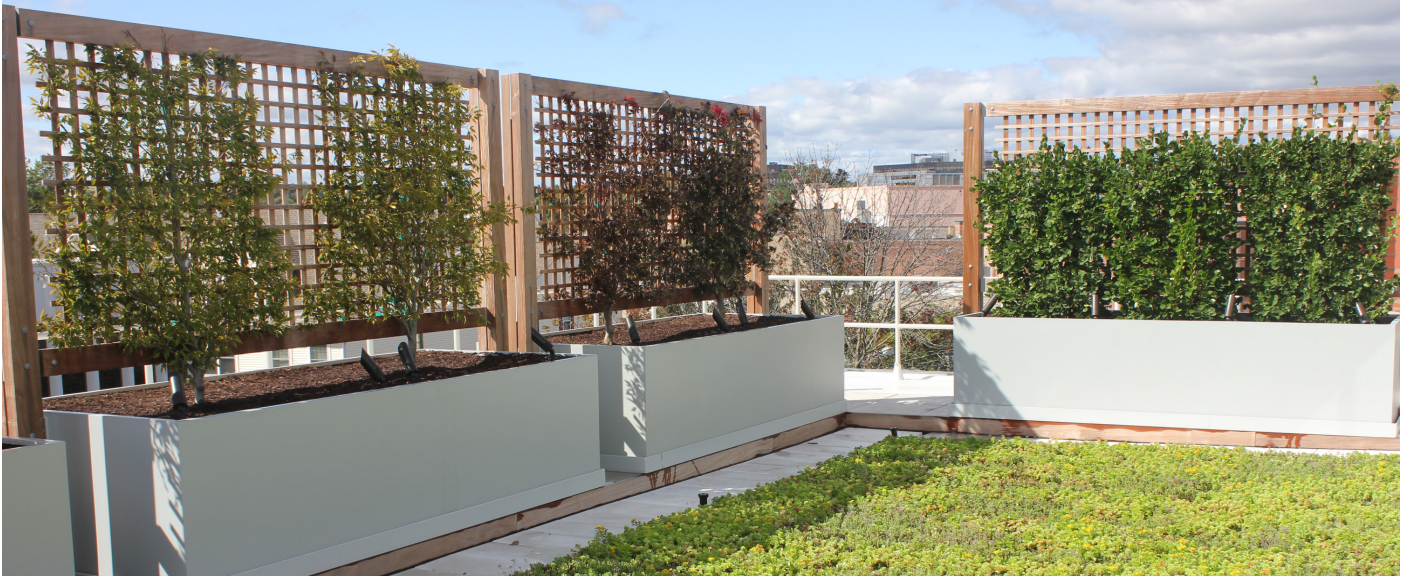
Tree planters and sedum frame the windows of this top-floor conference room, covering an uninspiring view of the black roof membrane

The goal in designing Stamford Community Health Center's green roof was to create a stunning landscape outside the top-floor conference room which, prior to the renovation, looked out upon a black roof membrane that reflected heat into the meeting room and increased cooling needs in the summer.

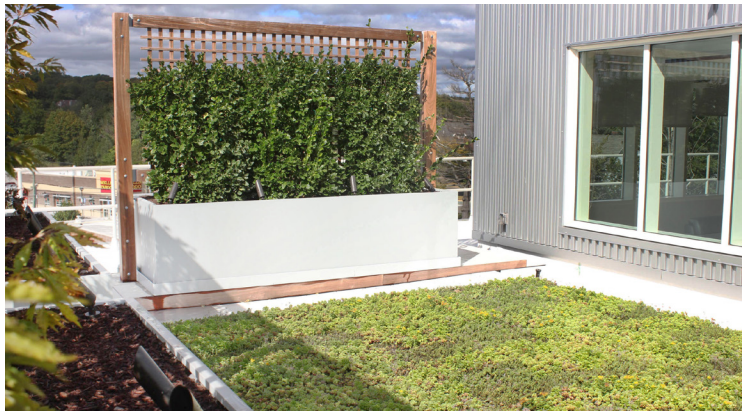
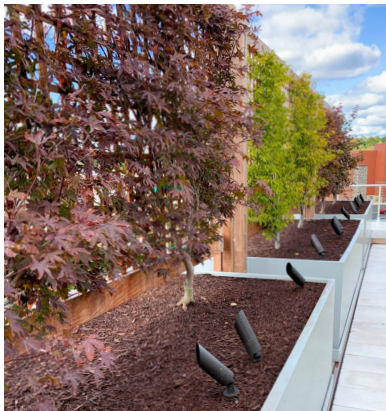
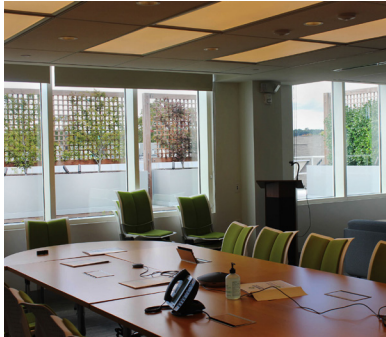
Top left to bottom right: Planters enclose sedum extensive area that provides added visual interest through year / Conference room windows looking out onto 2,000 sf green roof / Three types of trellised trees frame the view and provide cooling benefits in summer heat

Recover worked with Robert Olson Architects throughout the design development of this retrofit, managing weight restrictions of the roof. Installation occurred over two weekends; phase one consisted of Recover conveying and placing pavers as a platform for the tree planters. Phase two included conveyance and installation of: all green roof components, sedum mats, Tournesol planters, engineered soil media, and twelve espalier trees and trellises.
